REPORT 77-31

Roof moisture survey

Ten State of New Hampshire buildings

ROOF MOISTURE SURVEY: TEN STATE OF NEW HAMPSHIRE BUILDINGS

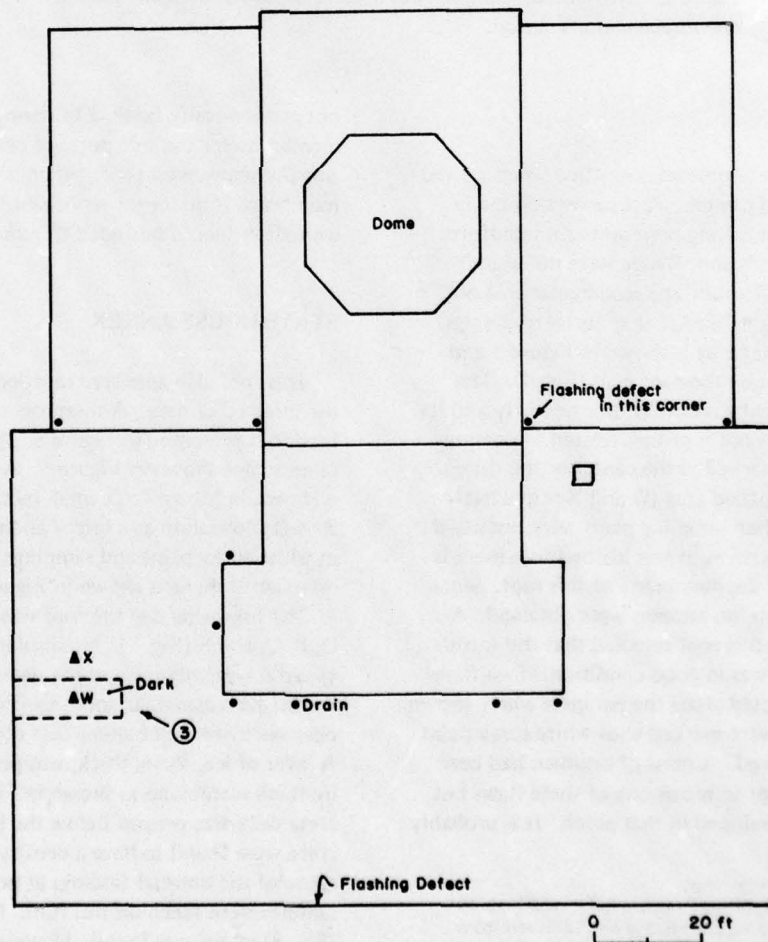
Figure 4. Plan view of State House roof. Circle and arrow indicate location and viewing direction of Figure 3.

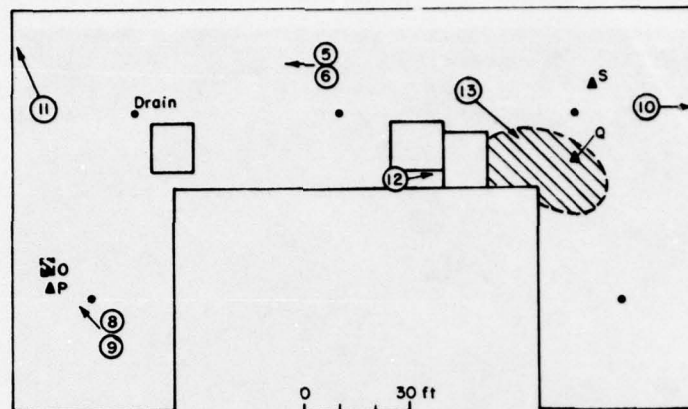
Figure 7. Plan view of the State House Annex roof. Circles and arrows indicate location and viewing direction of Figures 5, 6, and 8-13.

A larger, egg-shaped anomaly was also detected with the infrared camera (Fig. 13). It did not have a well-defined boundary as did the rectangular anomaly previously discussed nor was it as uniformly bright. A dashed line of white spray paint was used to approximate its extent (Fig. 7). At S the membrane was in good condition but at Q the membrane was brittle, dry and easily delaminated. No insulation was present under the membrane at either Q or S. S was in a mottled area similar to the area in Figure 5. The water content of chips of the concrete deck at points Q and S was determined to be 9% and 15%, respectively. It is likely that such differences in deck moisture explain the surface temperature differences seen by the infrared camera over most of this roof. Moisture in the concrete deck decreases its insulating value.

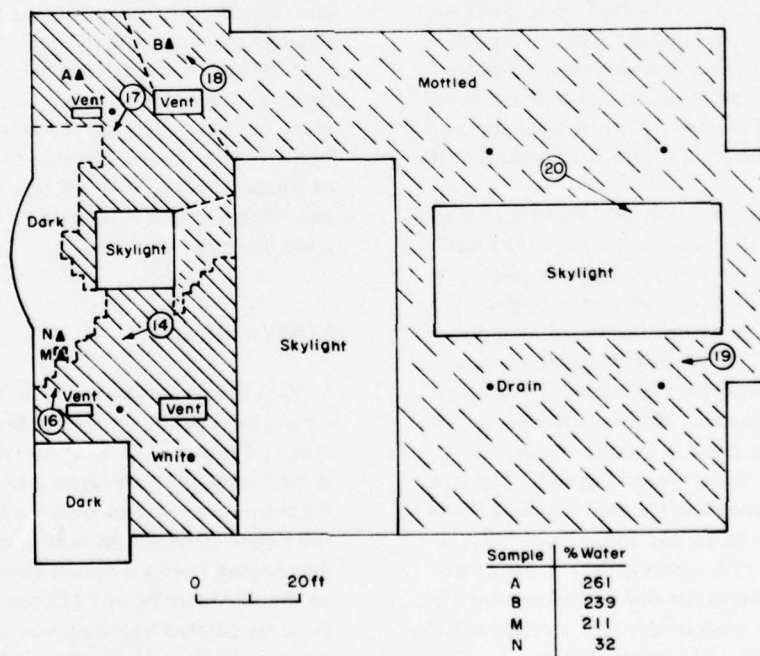
Figure 15. Plan view, State Library roof. Circles and arrows indicate locations and viewing directions of Figures 14 and 16-20.

Insulation samples taken at A and B (Fig. 15) had water contents of 261% and 239%, respectively.

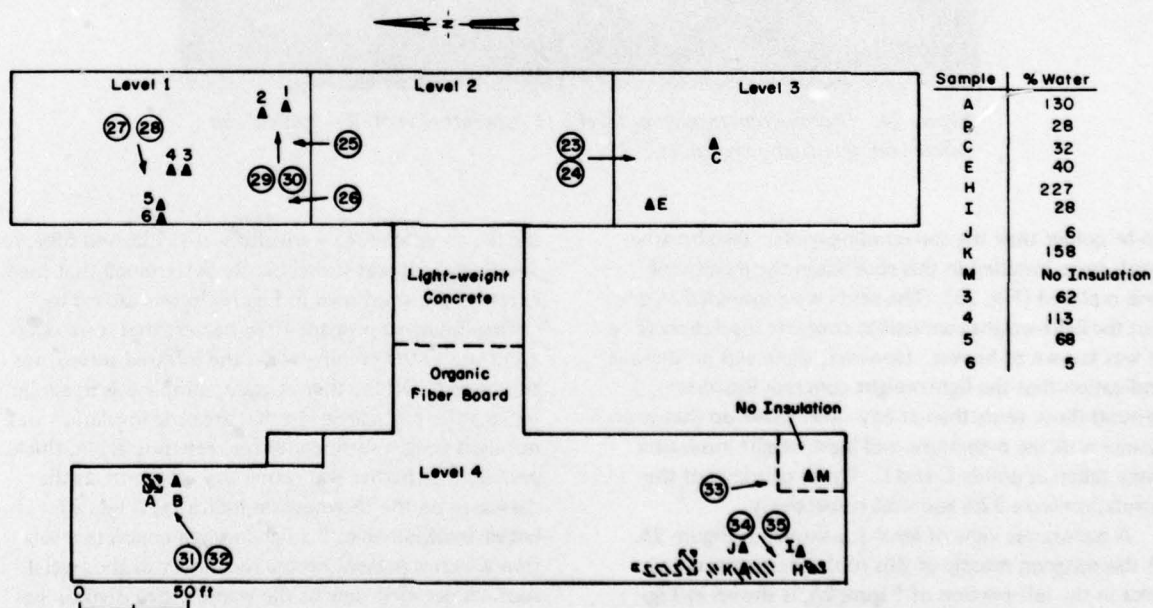
The roof of the Highway Garage was thermally complex. Four levels are present as indicated on the roof plan (Fig. 22). All levels are relatively flat with ridges along their centerline that provide slope sufficient to drain water to the eaves or to scuppers along the eaves. It is understood that the gravel-covered membrane is only a few years old.

Level 2, the highest area, harbored no thermal anomalies and was visually in good condition.

Figure 22. Plan view of the Highway Garage roofs. Samples were not taken at locations 1 and 2.

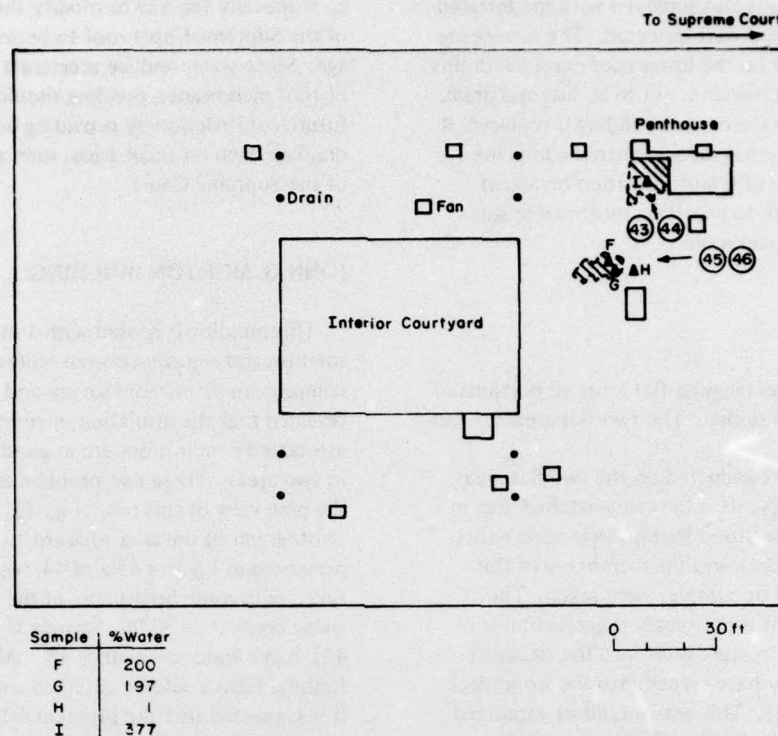
Figure 42. Plan view of the John O. Morton Building showing the two wet areas detected by the infrared camera and verified by core samples.

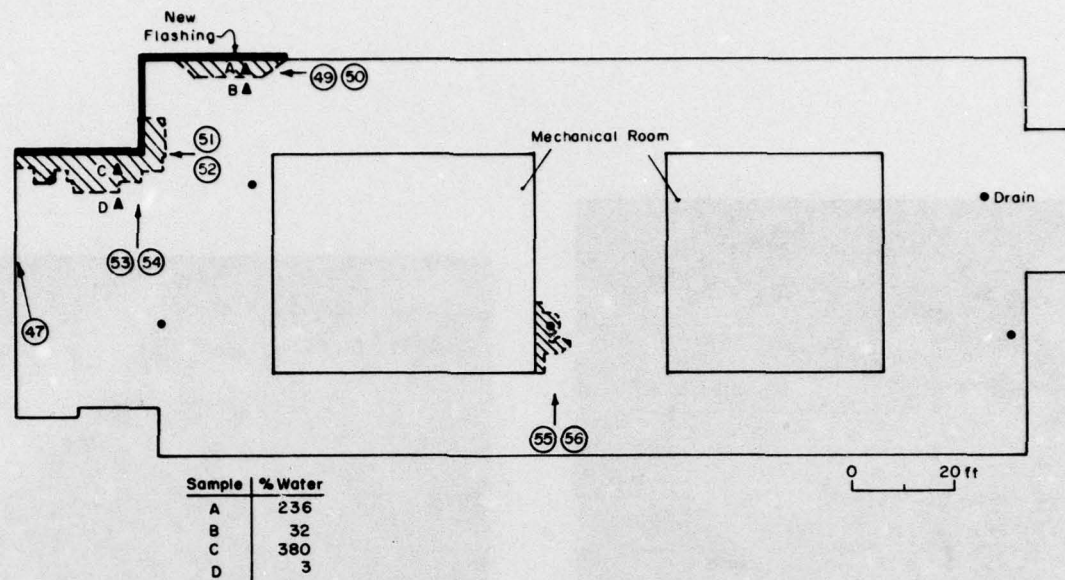
Figure 48. Plan view of the Department of Health and Welfare Laboratory.

This building is only a few years old but is suffering from chronic roof leaks. Visually the gravel-covered membrane is in excellent condition. The only visible flaw on the roof is the displaced parapet wall cap flashing in one area (Fig. 47). The location of this problem is shown in the plan view of this roof (Fig. 48). This material should be repositioned as soon as possible.

A comprehensive infrared survey of the roof uncovered three potential problem areas as shown in Figure 48. A thermogram and photograph of the first of these areas are shown in Figures 49 and 50. Insulation samples taken at A and B had water contents of 236% and 32% respectively. The perlite board insulation was

Sometime in the past the copper counter flashing along a portion of this wall was stolen. It is understood that this area remained without counter flashing for over half a year. The bold perimeter in the plan view (Fig. 48) has new copper counter flashing. It is quite likely that moisture entered this area during the period when the counter flashing was missing. Consequently, it is expected that the cause of this problem has been eliminated. Water in the insulation could cause membrane deterioration when it vaporizes in warm weather. Therefore, it is suggested that two breather vents be installed in this area in an attempt to dry out this insulation. There is some question whether this will work, but it is considered worth a try.

The second anomaly detected with the infrared camera was located nearby (Fig. 48). Two views of it are shown in Figures 51-54. Sample C, within the anomaly, had a water content of 380%, while sample D nearby (Fig. 52) had a water content of 3%.

The third and final thermal anomaly detected on this roof is shown in Figure 55. Figure 56 is a photograph of the same area. As can be seen in the photograph, a drain is located within the wet area and flashing abuts it. Also an open-ended drain pipe is suspended directly above the drain. No flashing, drain or membrane problems could be detected visually. It is recommended that the gravel cover be removed in this area to expose the membrane which should be examined for flaws. The drain should be disassembled and rebedded in the membrane. The flashing abutting the wet area should be examined in detail and, if possible, removed and replaced. A breather vent should be installed in an attempt to dry out this area and then a protective gravel cover added to complete the job.

As an alternative to the above, the membrane, insulation, flashing and drain in the wet area could be removed and replaced as was recommended for the two wet areas of the John O. Morton Building.

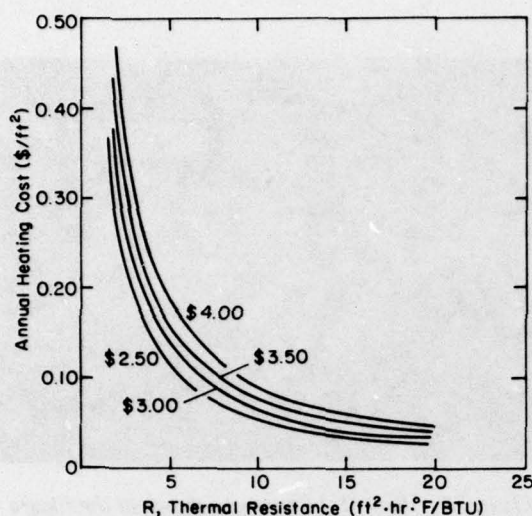
The State House, State House Annex, Legislative Office Building and State Library are heated by steam. From information obtained from State personnel, it was determined that the average cost of steam delivered to these buildings during the 75-76 winter was \$4.08/1000 lb. Since the steam is produced at 60 psig and the condensate leaves the building at about 150°F, 1060 Btu/lb are used. The relationship between annual fuel cost per square foot in Concord, New Hampshire, and thermal resistance is shown in Figure 57 for fuel costs of \$2.50, \$3.00, \$3.50 and \$4.00 per MBtu.

The thermal resistance of the wet insulation on the library roof was measured by Tobiasson and Dudley (1977). To their average value of $R = 6.9 \text{ ft}^2 \text{ hr } ^{\circ}\text{F}/\text{Btu}$ should be added $R = 0.8$ to account for inside and outside skin resistances. The total R equals 7.7 for this roof. From Figure 57, the annual cost of energy lost through this roof, based on those heat flux readings and a fuel cost of \$3.85/MBtu, is \$0.12/ft².

Figure 57. Curves that relate heating costs to thermal resistance for various fuel costs (\$/MBtu) for Concord, New Hampshire.

Means (1976) indicates that the cost of removing deteriorated roofing and insulation is about \$0.45/ft² and the cost of installing insulation with $R = 8$ and a new membrane is about \$1.24/ft². If $R = 16$ the new

insulation and membrane would cost an estimated \$1.74/ft². Total costs to remove and replace would then equal \$1.69/ft² ($R = 8$) and \$2.19/ft² ($R = 16$). ASHRAE (1975) recommends $R = 16$ for roofs of nonresidential buildings in Concord, New Hampshire.
